Bangladeshにおける河川堤防の性能と維持管理について (Performance and Maintenance of River Embankments in Bangladesh)

座狩屋 保世院*, 酒井 俊典*
Zakaria Hossain*, Toshinori Sakai*

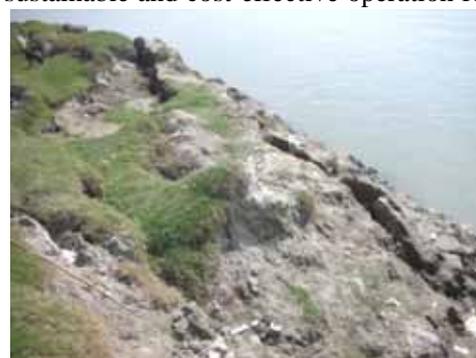
Fig.2 Embankments failure

Conclusions: The cause of failure of all the flood control embankments in the year 2007 could be attributed to erosion and sliding of embankments materials due to river encroachment and mitigation. Sand filled geotextiles bags and carpeting are used to protect the embankment from failure especially during the peak seasons flow. Concrete blocks are also used at some locations. Proper planning for long term stability needs to be taken into consideration to implement the geotextiles in timely manner.

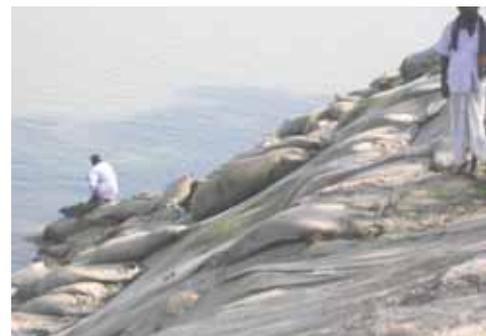
Fig.3 Geobags for bank protection
