Padma 川河川堤防の土質特性と破壊状況 (Geotechnical properties of Padma riverbank material and its failure mechanism)

○ベルラル ホッセイン, 酒井 俊典, 座狩屋 保世院
○Md. Bellal Hossain, Toshinori Sakai, Md. Zakaria Hossain

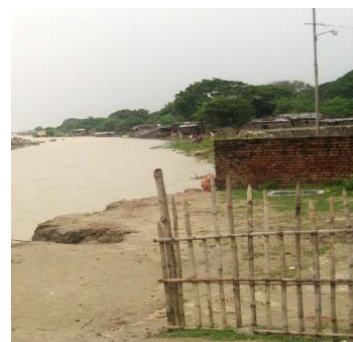
Figure 2 Study area

Padma is a major trans-boundary river which entered Bangladesh from India near Chapai Nababganj district. Rajshahi is a major city in western Bangladesh which is situated on the north bank of the Padma River (Fig.1). Sample materials of this study were collected from Charchat area of Rajshahi where bank failure was occurring largely during the field visit in 2008 (Fig.2).

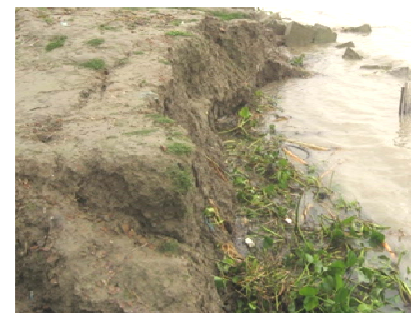
Figure 5 Riverbank failure

In the study area, the failure mechanism is mostly associated with the process of scouring at the base of riverbank causing the soil mass of the bank to slide downward and deposit on the toe. The deposited soil mass is then flushed away due to high velocity of water flow. As time passes, bank slope become steeper as a result of erosion at the lower part of the bank and again get ready for further failure in the same way. Small tension cracks at a distance from bank face are also seen that accelerate the mass failure of the riverbank (Fig.5). This type of failure can be described as Slab-type failure that includes both mechanisms of planar failure with tension crack, and toppling, involving failing blocks with the same geometry (slab-type blocks; Thorne, 1998).
