ジユムナ河川堤防材料の性質及び土嚢の利用について (Characteristics of Jamuna river embankment material and the use of sandbag)

ベルラル ホッセイン, 酒井 俊典, 座狩屋 保世院
Bellal Hossain, Toshinori Sakai, Zakaria Hossain

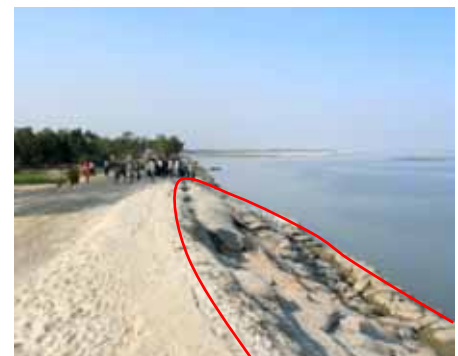
Fig.2 Failed Embankment of Jamuna

In Bangladesh, nearly 4,600 km of embankments along the bank of big rivers are flowing across the country. JAMUNA, one of the big rivers is flowing alongside of Sirajganj district of Bangladesh (Fig.1). At 41 locations of its bank, the length of failure occurring is about 160.62km¹. This is because of the fluctuation of water levels, siltation, scouring and severe wave actions of the river. In addition, devastating flood in almost every year and excessive rainfall are stepping up the early failure of embankments which results immense damage to agriculture and infrastructures. To minimize the impact of natural disasters as well as to achieve the goal of agricultural production, sustainable and cost-effective protection measures of those river embankments are now crucial for Bangladesh. Some of the major causes of these embankment failures are due to the use of geotechnically unstable materials, improper method of construction and insufficient post operative maintenance. So, prior to construction of a stable embankment it is important to evaluate the inherent properties of the construction materials for its safe design as well as to select appropriate protection system. Hence, the present article paid attention to investigate the physical as well as mechanical properties of the failed Jamuna river embankment materials at Sirajganj in Bangladesh. Consequently, an appropriate and sustainable method was sought as well to protect the bank of big river embankment like Jamuna (Fig.2) in Bangladesh.

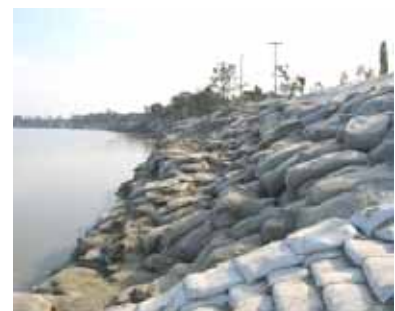
Fig.7 Sandbags on failed riverbank

So, the embankment constructed with this material can't be safe unless the quality of soil is improved by some means like . At present, a number of embankment protection techniques are being practiced in Bangladesh including launching of sandbag to riverbank. But, till now there is no particular specification as well as proper method has been developed for the successful use of sandbags. Consequently, the application of sandbags could not resolve the problem of embankment failure (Fig.7). Unlike the abundant availability of sand, Bangladesh doesn't have large quantities of rock such as stone and gravel etc. It is the cheapest and only readily accessible material throughout the construction season. So, the sandbag application could be the practical way of protecting riverbank in Bangladesh if it is done with proper design and specification. Moreover, a comprehensive study of its impact on the slope stability condition of embankment is necessary to make it sustainable.
