Padma 川河川堤防の土質特性と破壊状況 (Geotechnical properties of Padma riverbank material and its failure mechanism)

○ベルラル ホッセイン, 酒井 俊典, 座狩屋 保世院
○Md. Bellal Hossain, Toshinori Sakai, Md. Zakaria Hossain

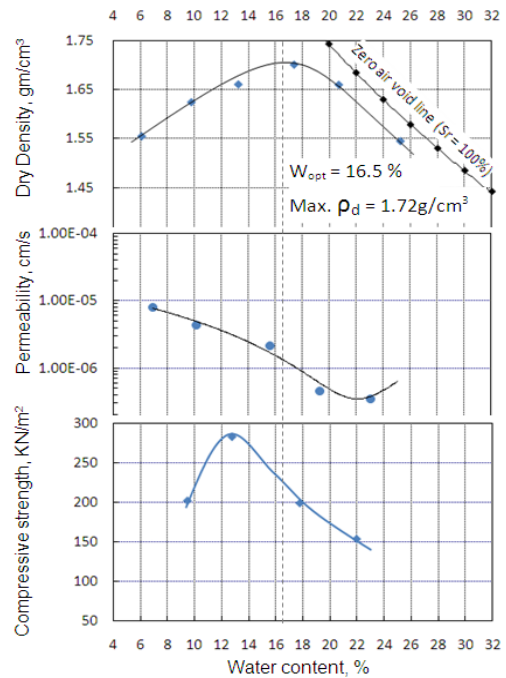
Figure 3 Variation of soil properties with water content

Since the strength of bank soil decreases rapidly with the increase of water content, and permeability also becomes lower ($<1 \times 10^{-6}$ cm/s) at the same time (Fig. 3), bank material weight increases which results shear failure at the upper face of bank. Moreover, during rapid drawdown of river water at the end of flood season groundwater table in the bank reduce gradually due to low permeability of the bank. This causes an imbalance in water pressure on the riverbank slope which may cause sudden mass failure of the bank. In this circumstance, slope stability analysis of this riverbank is necessary and it could be done according to Darby and Thorne, 1996, by which the limiting value of the critical bank slope and height can be determined. This is a new approach for riverbank stability analysis which can be applicable for the steep, cohesive, non-layered riverbank that fails along planar failure surfaces. In this method, Pore-water and hydrostatic confining pressure are also included where the failure plane is not constrained to pass through the toe of the bank.

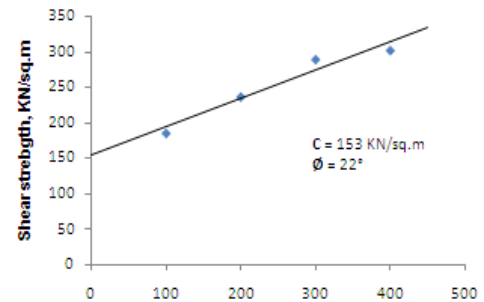
Figure 4 Failure envelop of bank soil

For the characterization of bank material, a number of laboratory tests were conducted which include the Particle size analysis, Particle density, Liquid limit, Plastic limit, Compaction, Consolidation, Permeability, Direct shear test and unconfined compressive strength tests. All the tests were followed by the methods of Japanese Industrial Standard (JIS) and Japanese Geotechnical society (JGS). The Results of basic physical properties are summarized in Table 1. According to JGS engineering classification the soil can be classified as silty soil which contents a significant percentage of clay (25%). The characteristics of the bank material with the variation of moisture content are shown in Fig. 3. The maximum bulk dry density (ρ_d) was found 1.72gm/cm^3 at optimum moisture content of 16.5%. The value of permeability is found very low, $3.5 \times 10^{-7}\text{cm/s}$, at over 90% saturation. Unconfined compressive strength is seen maximum of about 280KN/m^2 (at $w=13\%$). But, the strength decreases rapidly with the increase of the degree of saturation as observed from test results (Fig. 3). Direct shear test was conducted to determine the shear strength parameters (c and ϕ) of the bank material. The test results are plotted according to Mohr-Coulomb failure criteria as shown in Fig. 4. From test results, it is found that the bank material has a good cohesive value (c) of about

153KN/m² with the value of internal friction angle, $\phi=22^\circ$. The cohesion calculated from compressive strength ($c=\frac{q_u}{2}$) is about 115 KN/m² at optimum water content.
